### Conforma Clad™ Solutions for Economizer to SCR

## SCR Turning Vane Structural Components

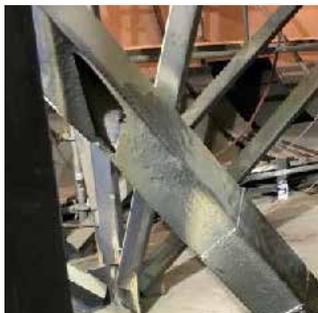
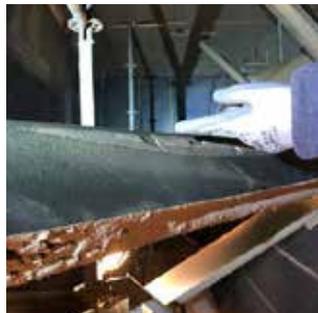
Eroded Structural Members

Apply 0.030" WC-210 cladding to angle iron wear surface.  
Turn key iron in required sizes provided.

- Significant life cycle improvement.
  - Cladding Abrasion Resistance Factor (ARF) over 10x better than hardened steels.
- Considerable savings over life cycle of clad angle iron.
  - Reduction in frequency of expensive vane maintenance.
  - Reduction in lost production (frequency and time required to build scaffolding).

Erosive wear of the structural components (Angle Iron) used to secure the ducts and turning vanes located at the Ammonia Injection Grid (AIG) exit of economizer to SCR.

- Angle iron needed to be replaced during regular outages — every 2 years.
- 250' of scaffolding needed to be constructed to access.
- Estimated cost >\$1m.
- Time taken to complete — 10 days on 2-shift basis.

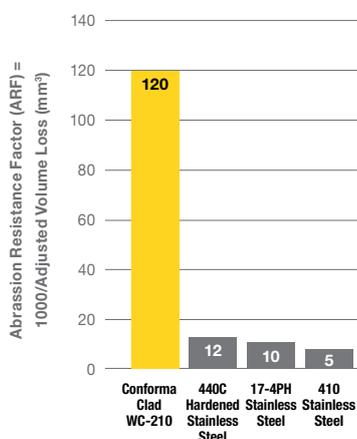
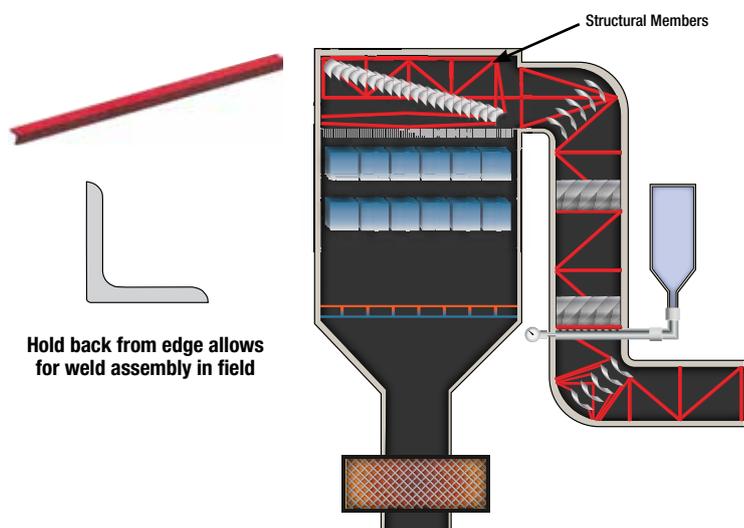
## Dry Sand Abrasion Test (ASTM G65)

**Cladding Abrasion Resistance Factor (ARF) over 10x better than hardened steels.**

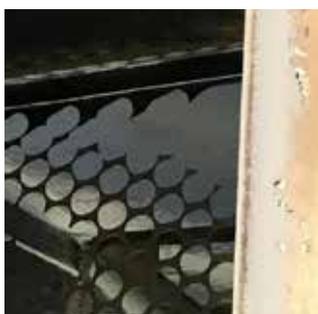
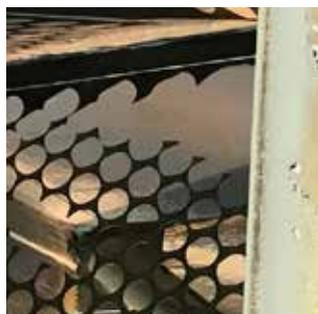
Eroded Structural Members

UltraFlex™ carbide coating of perforated screen.

- Significant life cycle improvement.
- Fewer screen replacements.

Erosive wear of the perforated plates, located before the Ammonia Injection Grid (AIG).

- Perf plates needed to be replaced during regular outages — every 6 months.
