## Conforma Clad™ Solutions for Economizer to SCR

### Problem — Structural Components

Erosive wear of the structural components (Angle Iron) used to secure the ducts and turning vanes located at the Ammonia Injection Grid (AIG) exit of economizer to SCR.

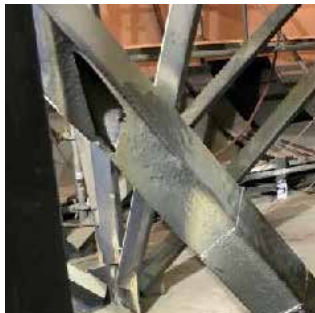
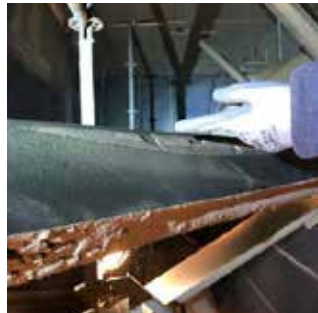
Eroded Structural Members

## SCR Turning Vane Structural Components

Apply 0.030" WC-210 cladding to angle iron wear surface.  
Turn key iron in required sizes provided.

- Angle iron needed to be replaced during regular outages — every 2 years.
- 250' of scaffolding needed to be constructed to access.
- Estimated cost >\$1m.
- Time taken to complete — 10 days on 2-shift basis.

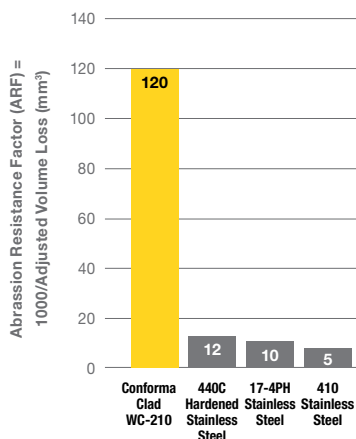
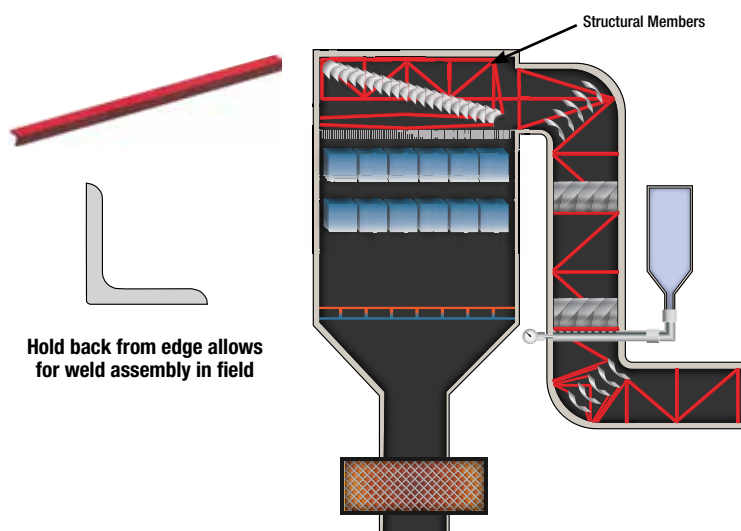
## Dry Sand Abrasion Test (ASTM G65)

**Cladding Abrasion Resistance Factor (ARF) over 10x better than hardened steels.**

- Significant life cycle improvement.
  - Cladding Abrasion Resistance Factor (ARF) over 10x better than hardened steels.
- Considerable savings over life cycle of clad angle iron.
  - Reduction in frequency of expensive vane maintenance.
  - Reduction in lost production (frequency and time required to build scaffolding).

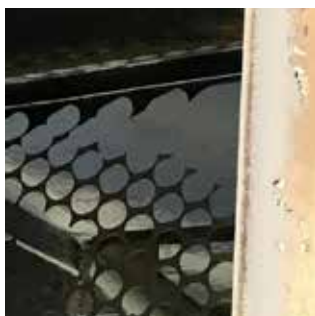
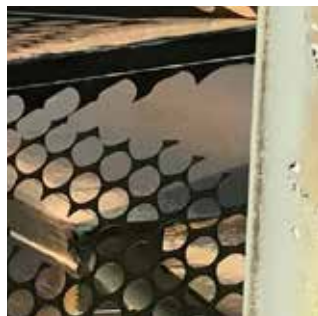
Eroded Structural Members

## Perf Screens Located Behind AIG

UltraFlex™ carbide coating of perforated screen.

Erosive wear of the perforated plates, located before the Ammonia Injection Grid (AIG).

- Perf plates needed to be replaced during regular outages — every 6 months.
