# Solvay Advanced Polymers, L.L.C.

Augusta, Georgia

**Reduced conveyance system blowouts — significantly decreasing labor, parts, and lost-product costs.**

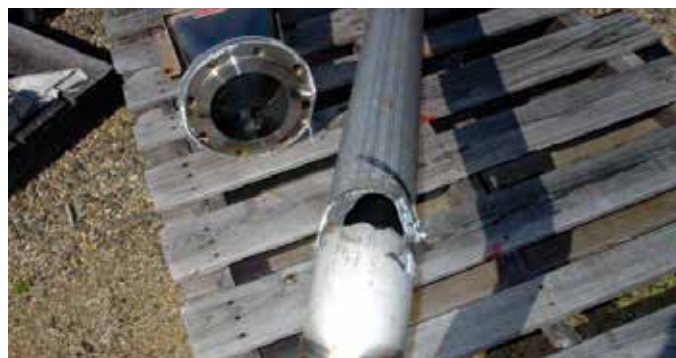
Elbow and pipeline blowouts were common before Solvay installed Kennametal conveyance components.

When Solvay Advanced Polymers began plastics compounding operations in its Augusta, Georgia facility 16 years ago, they faced unexpected conveyance line failures caused by severe abrasion and erosion. The plant experienced multiple elbow and pipeline blowouts throughout their dilute phase pneumatic conveyance system less than two weeks after their first compounding line began.

Undetected blowouts plagued the conveyance system, costing the plant more than \$200,000 annually in lost product, with each hour of undetected blowout costing \$4,000. The plant spent an additional \$60,000 a year on labor to repair the daily equipment blowouts. Eventually, the blowouts began to create significant yield reductions, affect process distributions, and cause safety and housekeeping issues.

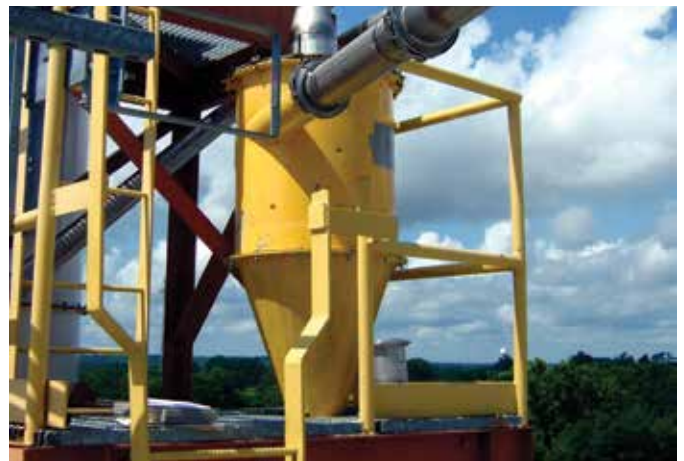
Cyclone clad with Kennametal infiltration braided tungsten carbide wear protection.

Our proprietary infiltration-brazed tungsten carbide cladding is metallurgically bonded to component surfaces. The Kennametal cloth delivery system enables densely packed tungsten carbide to be uniformly applied to complex geometries, providing a protective layer that wears at a uniform and predictable rate. The result is a durable cladding that is extremely abrasion- and corrosion-resistant.

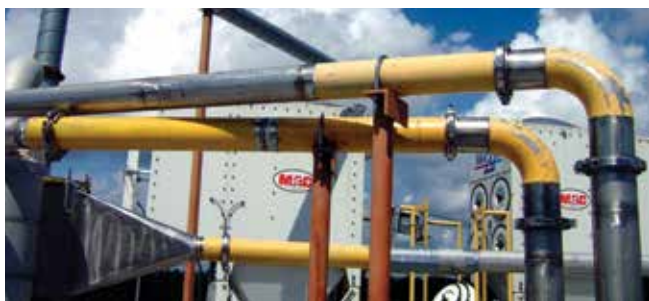
*Solvay paints Kennametal components yellow to distinguish them from unprotected piping.*

Solvay's Mike Clark and Stan Branham used to spend their time making daily weld repairs on elbow and piping blowouts throughout the plant. Today, they concentrate on proactive projects instead of reacting to unexpected blowouts. Branham says, "Every time an unprotected pipe blows, we replace it with one from Kennametal. We paint all of the Kennametal parts yellow. One day, we'd like to paint the whole line yellow."
